NASA Technical Paper 1609

Scanning-Electron-Microscope
Study of Normal-Impingement
Erosion of Ductile Metals

William A. Brainard and Joshua Salik

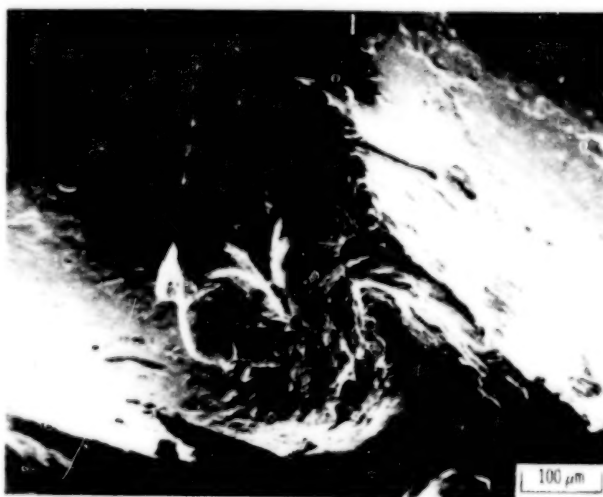
Figure 3 - Annealed 6061 aluminum surface after adjacent impacts by 3.2-millimeter-diameter steel ball at 140 meters per second.

per second. Of particular interest are the region between two adjacent impacts and the region below (subsurface) the impact zone. Figure 3 presents higher magnification micrographs, in this case from an aluminum surface, of the extruded metal peaks. Note in particular the extensive cracking and the layer-like structure. Very thin lamellae of aluminum were observed to occur on the sides and bottoms of impact craters (fig. 4). Such lamellae are likely to be easily detached on subsequent impacts. Transfer of aluminum in very thin layers to a steel ball on impact had been confirmed by X-ray analysis (ref. 12). The amount of transferred material per impact seemed to increase with the number of impacts.

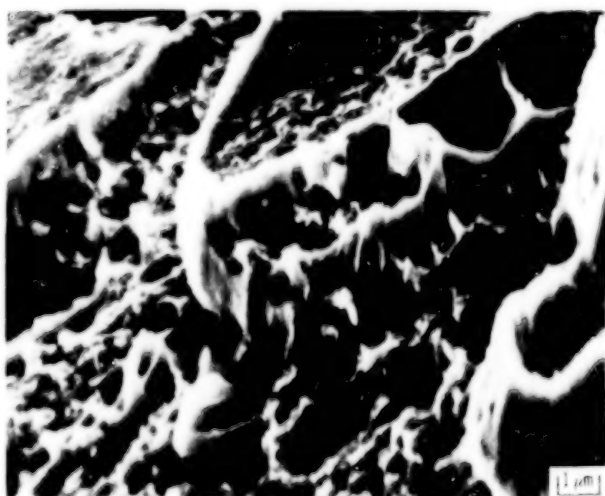
Figure 7. - Bottom of crater in annealed copper surface after five impacts by 3.2-millimeter-diameter steel ball at 140 meters per second.

The lamellae were not observed for copper. Rather, copper exhibits the formation of a thicker, highly deformed layer (fig. 5) and, with repeated impacts, both lateral and transverse cracking (fig. 6). Adhesive transfer of copper to the steel ball occurs, and the amount appears to increase with the number of impacts (i.e., the amount per impact increases with total number of impacts). There is clear evidence of tensile fracture in the copper as a result of adhesion during impact. The micrograph of figure 7 shows a region near the bottom of an impact crater made in an annealed copper sample that had been impacted several times. A layer of material nearly 1 micrometer thick had been removed. Analogous pictures of the ball surface after this impact are shown in figure 8. The X-ray map

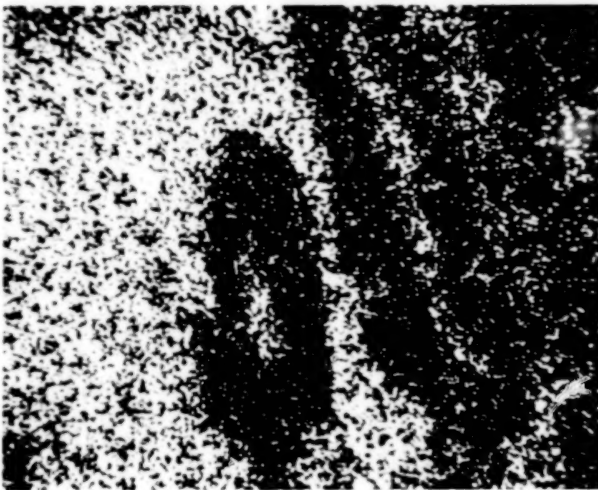
(a) Scanning electron micrograph.

(b) Copper K_{α} map.

Figure 8 - 3.2-Millimeter-diameter steel ball after 140-meter-per-second impact into annealed copper previously impacted four times.

clearly shows a rather heavy film of copper transferred onto the steel surface. It is likely that, with repeated impacts, fracture is more extensive because of the presence of cracks from previous impacts. No marked change in mechanisms could be inferred for either copper or aluminum as the number of impacts increased.

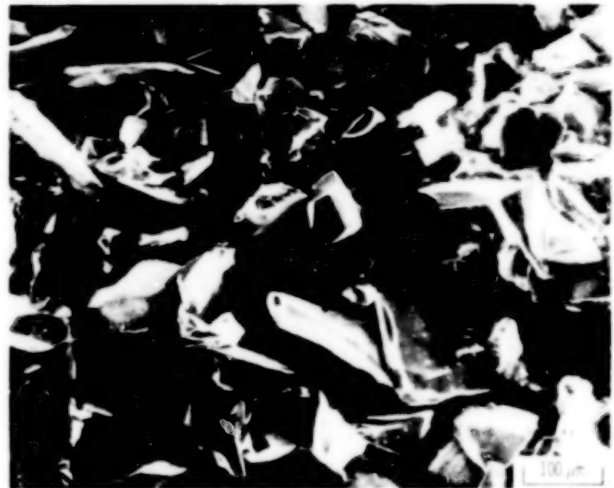
(a) Silicon carbide particles.

(b) Glass beads.

Figure 9 - Erodant particles.

Most erosion-causing particles in actual operating systems are considerably smaller and more angular than the steel balls used for the experiments described in the previous section. To observe if there were differences between the larger steel balls and actual erodant particles, the surfaces of annealed copper and aluminum samples were impacted by compacts of erodant particles of aluminum oxide and silicon carbide and glass beads. Figure 9 shows micrographs of silicon carbide particles and glass beads. The aluminum oxide particles were similar to the silicon carbide particles in size and shape.

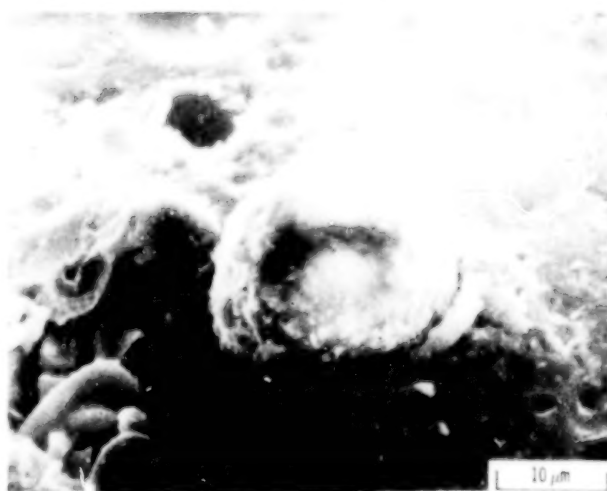
(a) Silicon carbide particle

(b) Glass bead.

Figure 11 - Eroding particles embedded in 6061 aluminum after impacting at 93 meters per second.

data were for 125- to 150-micrometer quartz particles. In addition to fragmenting, the smaller erodant particles, particularly the angular particles, often become embedded in the ductile metal surfaces (fig. 11). This effect has been reported before and accounts for initial weight gains reported in some experimental studies of erosion (ref. 13).

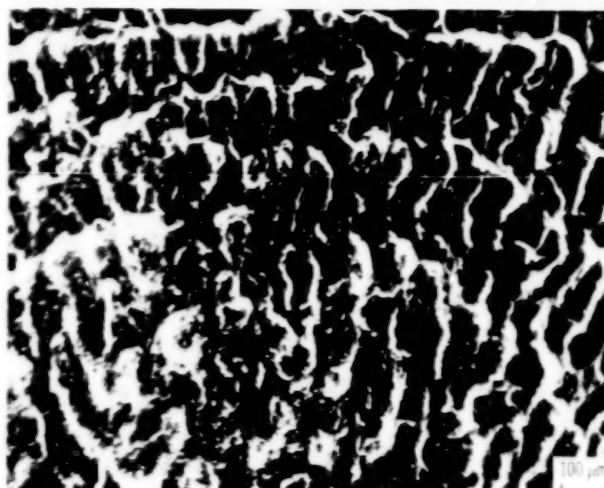
(a) Gas gun (impact velocity, 93 m/sec).

(b) Industrial abrasive machine.

Figure 12 - Annealed 6061 aluminum surface eroded by glass beads impinged by two methods.

Surfaces of aluminum that were eroded both by gas gun at 93 meters per second and by exposure to the stream produced by an industrial air abrasive machine are shown in figure 12. Both surfaces were eroded by the same-size spherical glass beads. Clearly, the surface resulting from bombardment by means of the gas gun is more severely damaged, and both particle fragmentation and embedment have occurred. The surface resulting from bom-

bardment by means of the industrial machine exhibits overlapping, plastically deformed craters without any evidence of particle fragmentation. This suggests that although the gas-stream velocity through the nozzle may be rather high, the actual particle velocity may be much lower. This was confirmed by Neilson and Gilchrist (ref. 14), who actually measured the erodant particle velocities photoelectrically and compared those values with the calculated efflux velocity of the gas stream. They found that the particle velocity, depending on the particle mass to gas mass ratio, could be less than one-fourth the efflux velocity.
